44TH TURBOMACHINERY & 31ST PUMP SYMPOSIA
HOUSTON, TEXAS | SEPTEMBER 14 – 17 2015
GEORGE R. BROWN CONVENTION CENTER

Export Gas Compressors Vorecon vibration Analysis

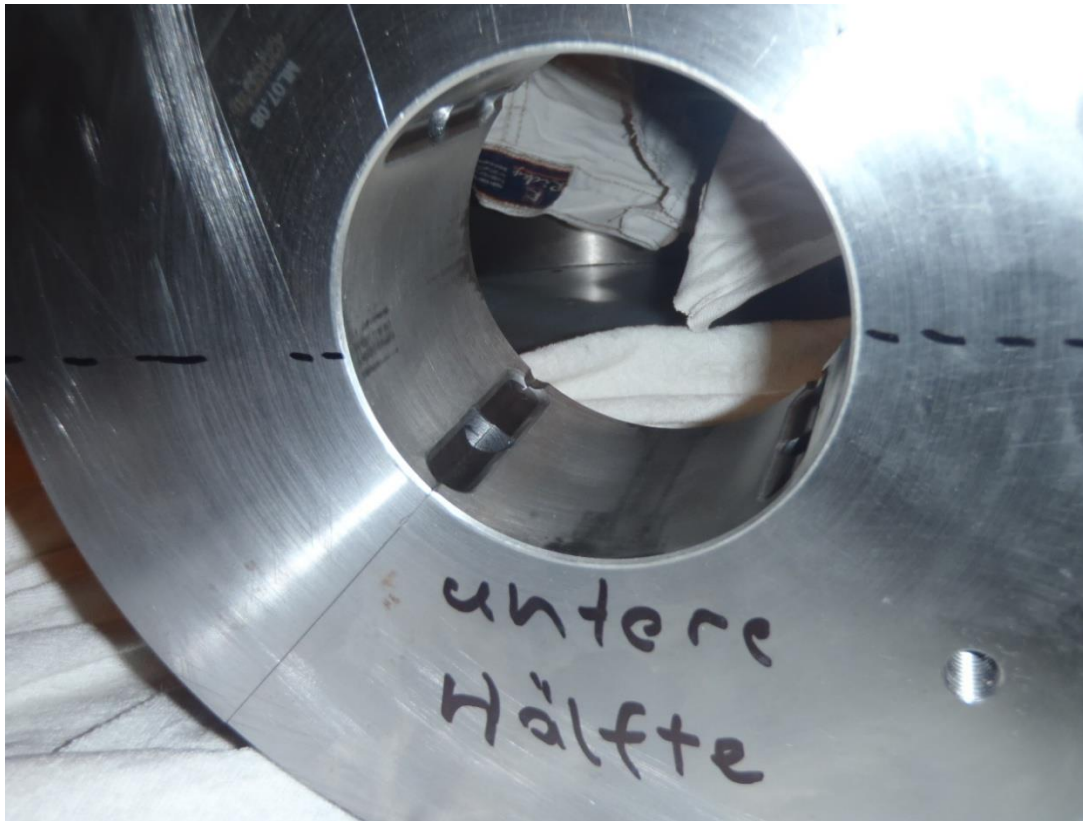
Inspection of the bearing 11 show no damage. The wear on the surface is a link to the increased vibration.
